**DEPARTMENT OF TRANSPORTATION**

Contract #: 04-0120F4Cty: SF/ALA Rte: 80 PM: 13.2/13.9File #: 1.28**WELDING INSPECTION REPORT****Resident Engineer:** Pursell, Gary**Address:** 333 Burma Road**City:** Oakland, CA 94607**Report No:** WIR-012003**Date Inspected:** 16-Feb-2010**Project Name:** SAS Superstructure**OSM Arrival Time:** 700**Prime Contractor:** American Bridge/Fluor Enterprises, a JV**OSM Departure Time:** 1530**Contractor:** American Bridge/Fluor Enterprises, a JV**Location:** Job Site**CWI Name:** Bill Norris/Bonafacio Daquinag**CWI Present:** Yes No**Inspected CWI report:** Yes No N/A**Rod Oven in Use:** Yes No N/A**Electrode to specification:** Yes No N/A**Weld Procedures Followed:** Yes No N/A**Qualified Welders:** Yes No N/A**Verified Joint Fit-up:** Yes No N/A**Approved Drawings:** Yes No N/A**Approved WPS:** Yes No N/A**Delayed / Cancelled:** Yes No N/A**Bridge No:** 34-0006**Component:** Orthotropic Box Girder (OBG) 1/4 West**Summary of Items Observed:**

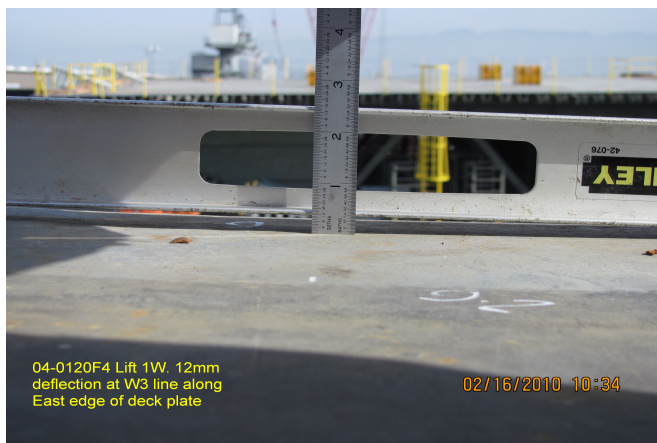
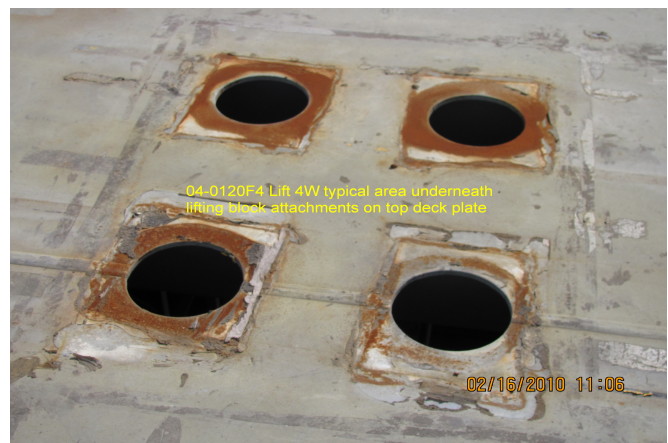
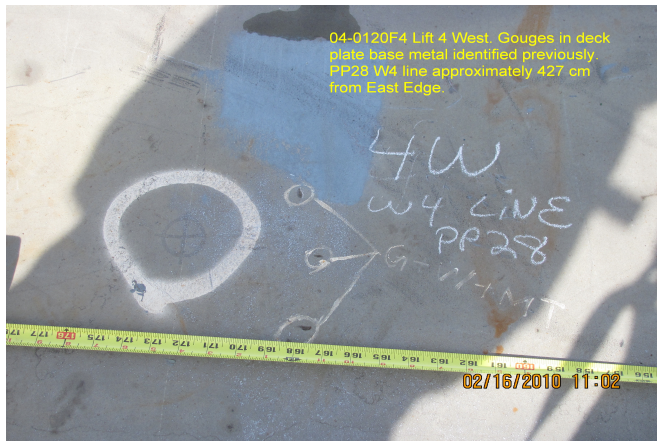
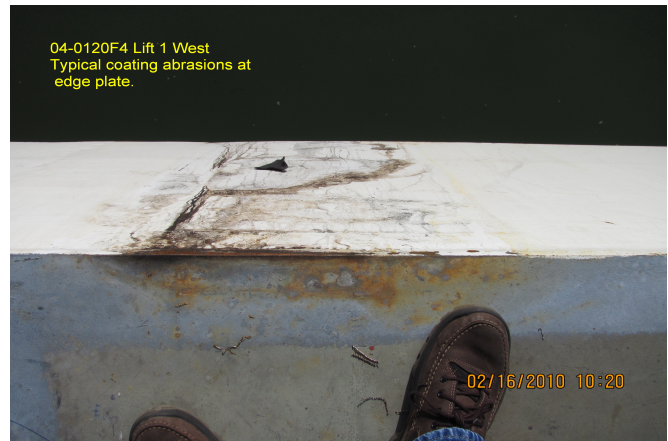
No apparent transportation issues observed. Three gouges in the top deck plate were noted by QA in which it appeared the areas were previously identified for minor base metal repair in China. The areas are at PP28 at the W4 line approximately 427 cm from the East edge of the OBG. A digital photo is included in the body of this report. It was noted the lifting block attachments have been removed on this section with typical coating issues observed which will be remedied at a later date after final placement in the structure.

LIFT 1 West – ABF personnel are in the process of grinding and buffing the bevel edges in preparation of performing the fit up and welding of the transverse weld seam in the field. A crew of ABF personnel are in the process of placing the lumber toe-boards on the top deck and the lay-out of the access holes which will be cut into the top deck plate.
